Strong ground motions and damage patterns from the 1999 Duzce earthquake in Turkey

Journal of Earthquake Engineering, 10(5)

## **STRONG GROUND MOTIONS AND DAMAGE PATTERNS FROM THE 1999 DUZCE EARTHQUAKE IN TURKEY**

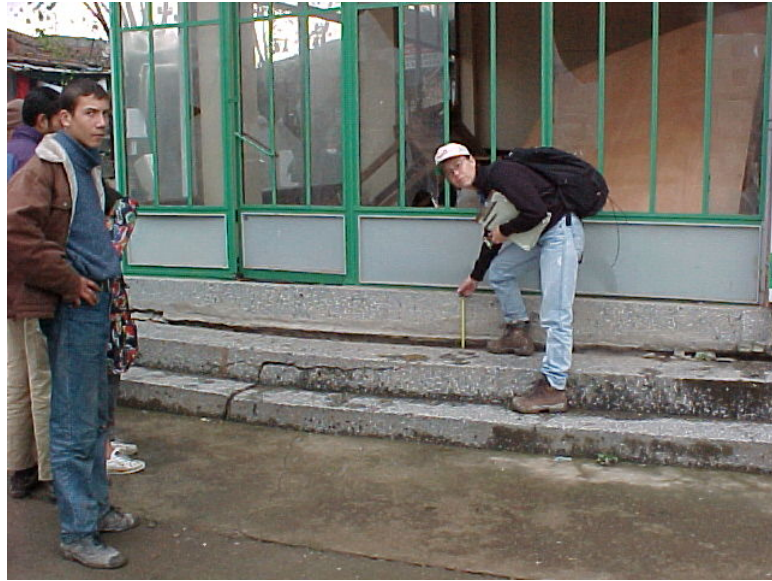
m deep. The location of the ground water table may have played a role in the absence of liquefaction during this earthquake. The Bayindirlik (2000) study indicates that the lowest groundwater levels occur during the month of October. Although no liquefaction was observed, the zones in Figure 10 may still indicate locations of relatively recent and poorly consolidated sediments. Ground settlements of 1 to 2 cm were observed adjacent to buildings at a few isolated locations in Duzce (Figure 11).

Figure 11. Localized ground settlement of 1 cm adjacent to building (N40.8389, E31.1548)

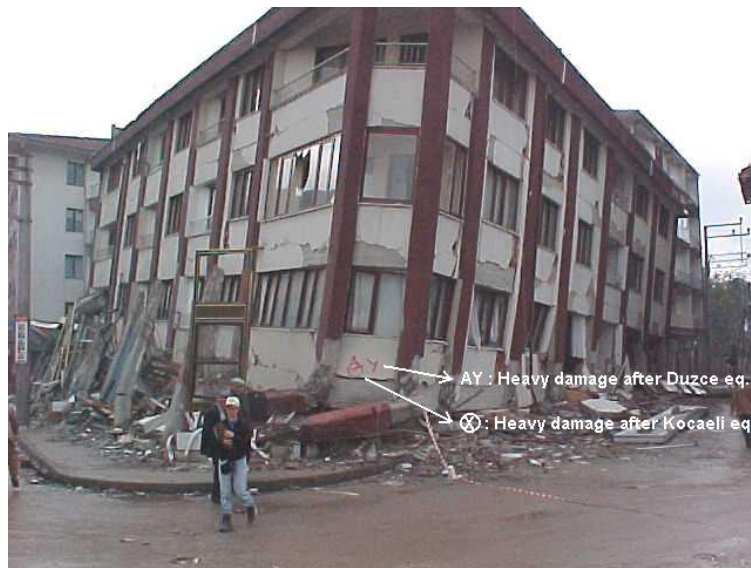
Many of the buildings reflected in these statistics were originally damaged during the August 1999 Kocaeli earthquake. These buildings typically had been marked with an 'X' after the Kocaeli event to indicate they were unsafe to occupy (e.g., Figure 12). It is not known what percentage of the buildings reported as damaged following the Duzce event had originally been damaged by the Kocaeli event, although visual observations of the 'X' markings by the authors suggest this ratio to be less than one third.

Figure 12. Collapsed building in Duzce that had already been damaged during the Kocaeli event (N40.83678, E31.1582)

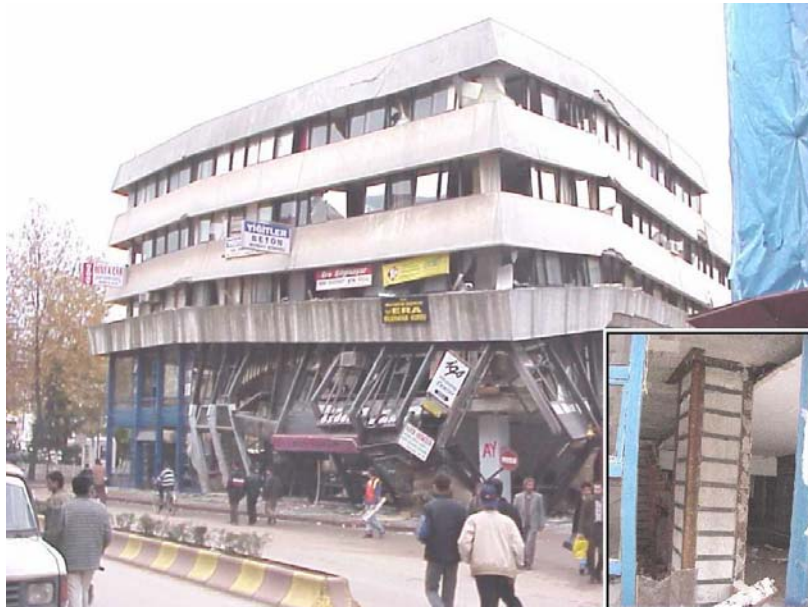
In Duzce and other areas affected by the Kocaeli earthquake, retrofit measures had been undertaken to provide confinement for reinforced concrete columns in frame buildings. One such building is shown in Figure 15, with a detail view of the column confinement system indicated in the inset. These retrofitted buildings appeared to perform well. The building in Figure 15 provides a clear indication of the retrofit effectiveness. Most of the perimeter columns in this structure had been retrofitted, with the exception of some of the second story columns. The collapse was caused by the failure of the second story corner column nearest the photographer in Figure 15.

Figure 15. Building in Duzce that had been retrofitted after the 1999 Kocaeli earthquake (N40.5034, E31.0952)

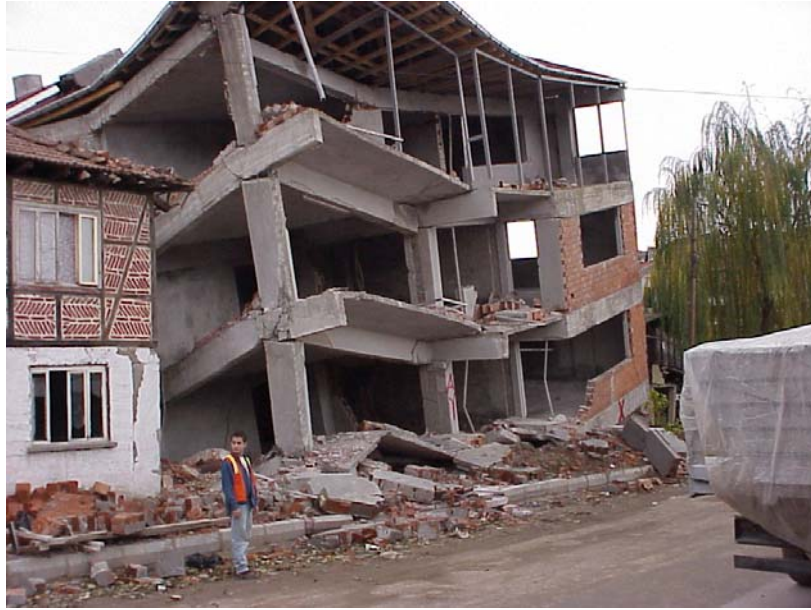
Figure 17. Example of poorly reinforced structure with no bonding between structural members in Kaynasli (N40.4631, E31.1923)

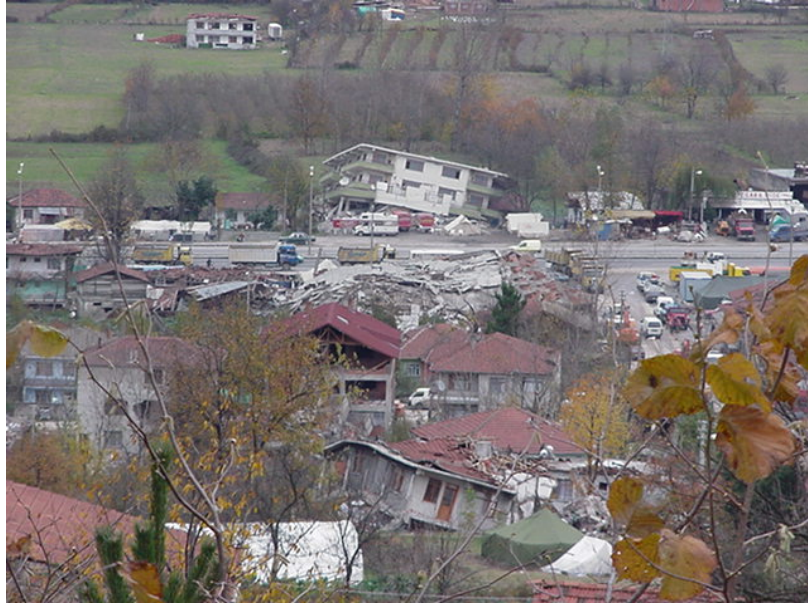
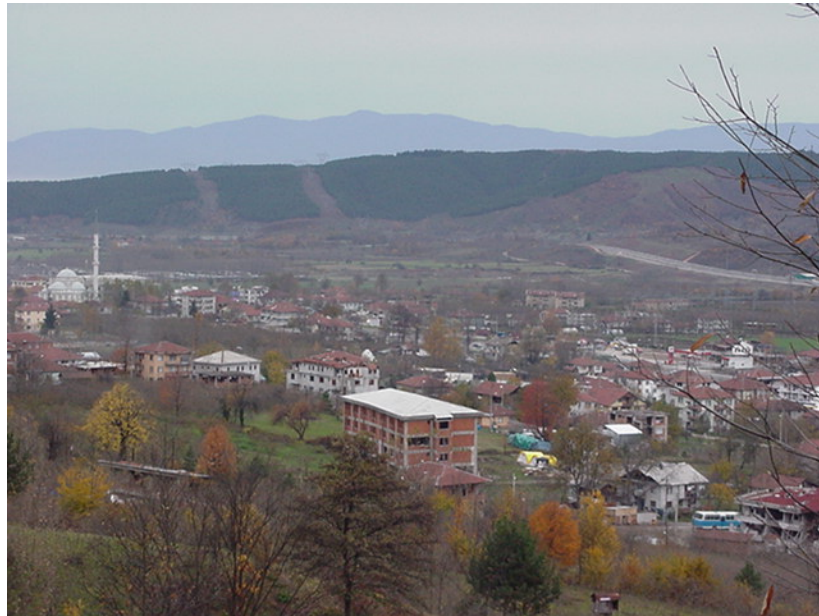
Buildings in the downtown area (Merkez District) suffered a collapse rate of 64%, whereas buildings further to the west (and somewhat closer to the fault) had collapse rates on the order of 25 to 30%. Figures 18 (a) and (b) show overviews of the downtown Merkez area and the less damaged Sariyer area further west. As shown on Figure 16, the downtown area is underlain by a southward protrusion of the alluvium along the flysch/alluvial boundary. Less damaged areas further to the west are underlain by flysch deposits. This apparent association of damage with surface geology suggests possible ground motion amplification in the shallow alluvial sediments.

Figure 18(a) View of Merkez District, Kaynasli, looking north  
(N40.4629, E31.1931)

Figure 18(b) View of Sariyer district, Kaynasli, looking north-west  
(N40.4629, E31.1931)
